ABERLADY MARKET CROSS, ABERLADY

17th July 2013

Aberlady Market Cross, Aberlady

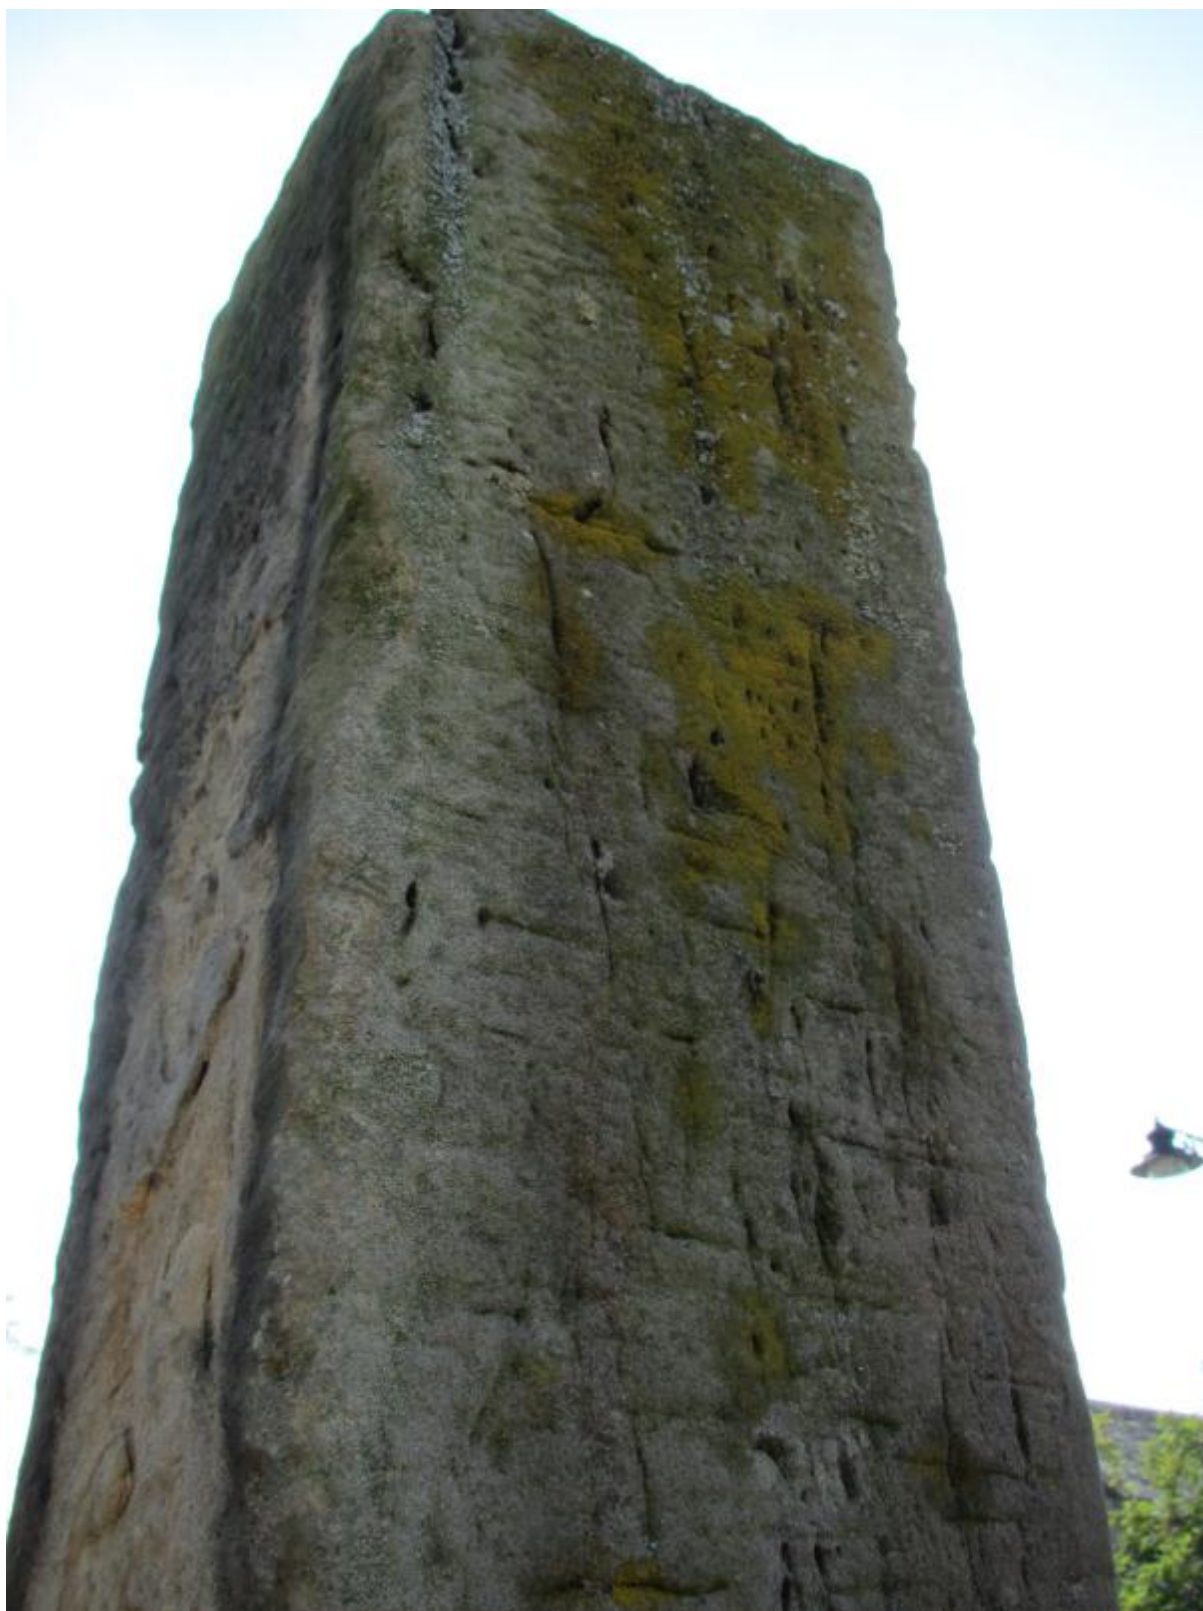
Evidence of biological growth is minimal and mainly confined to the west elevation and generally the upper parts of the shaft. Here green biofilm and lichen are apparent.

Upper section of the shaft viewed from the west

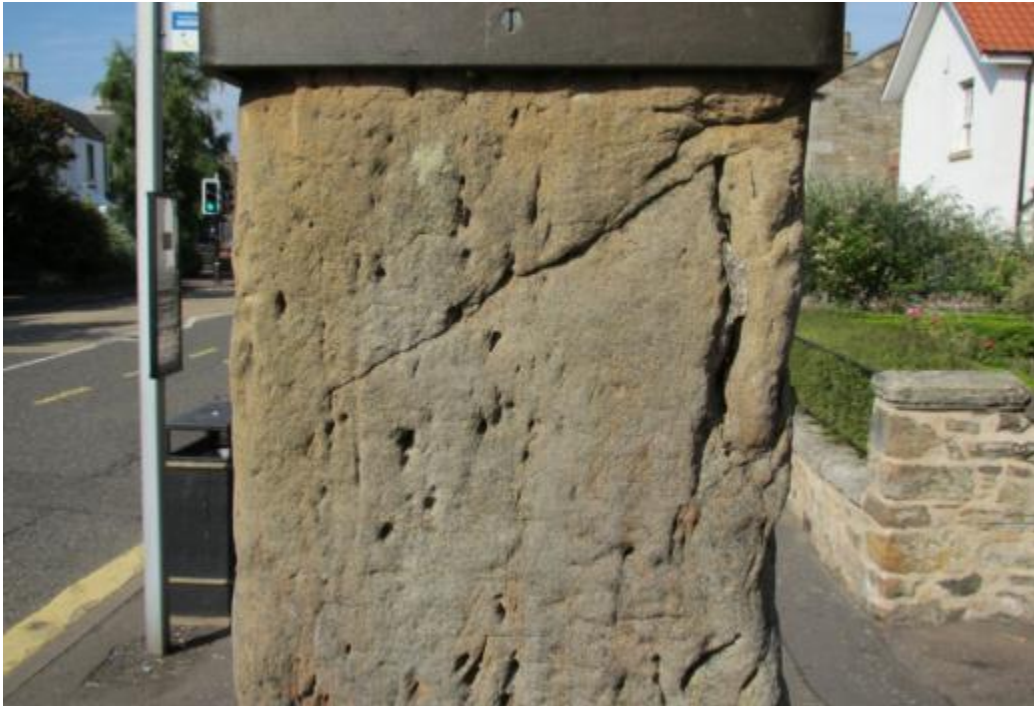
The shaft is stable in its base displaying no evidence of structural instability as a whole. The two bronze bands are in good condition and remain secure. The ferrous screw on the east side is oxidising causing some slight rust staining.

East elevation

- The metal bands remain functional and only the ferrous screw/s should be considered for replacement with a bronze item/s.
- Areas of fracturing and superficial damage on the steps should be repaired with acrylic mortar.
- The small indent on the base of the shaft should be repointed at the sides to prevent water ingress.
- The pointing remains in good condition and unless there are any very localised areas of deterioration should not require further intervention. The only construction joint that would benefit from repointing is that between the shaft and the plinth stone. An appropriate lime mortar should be used for this.

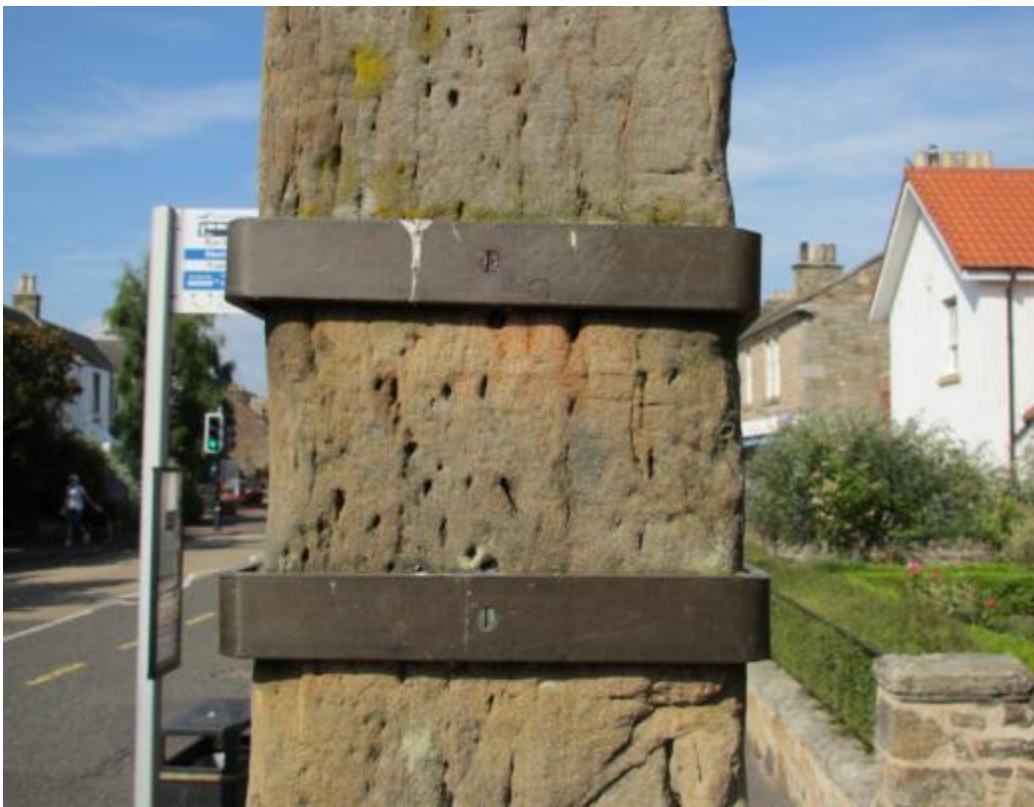
The small stone indent on the north elevation remains functional although the lime pointing has failed in areas allowing water ingress. On the east side there is an open bedding fracture extending up the side of the indent to just below the lowest of the two metal bands where it intersects with a diagonal hairline fracture. There is evidence of some filler in the more open parts of the fracture although most has been lost. The diagonal fracture extends right around the centre of the shaft and it is this that has presumably given cause for concern hence the metal bands. As the fracture extends below and above the bands they only partially provide the necessary reinforcement although it appears to be adequate given the angle of the fracture.

East elevation

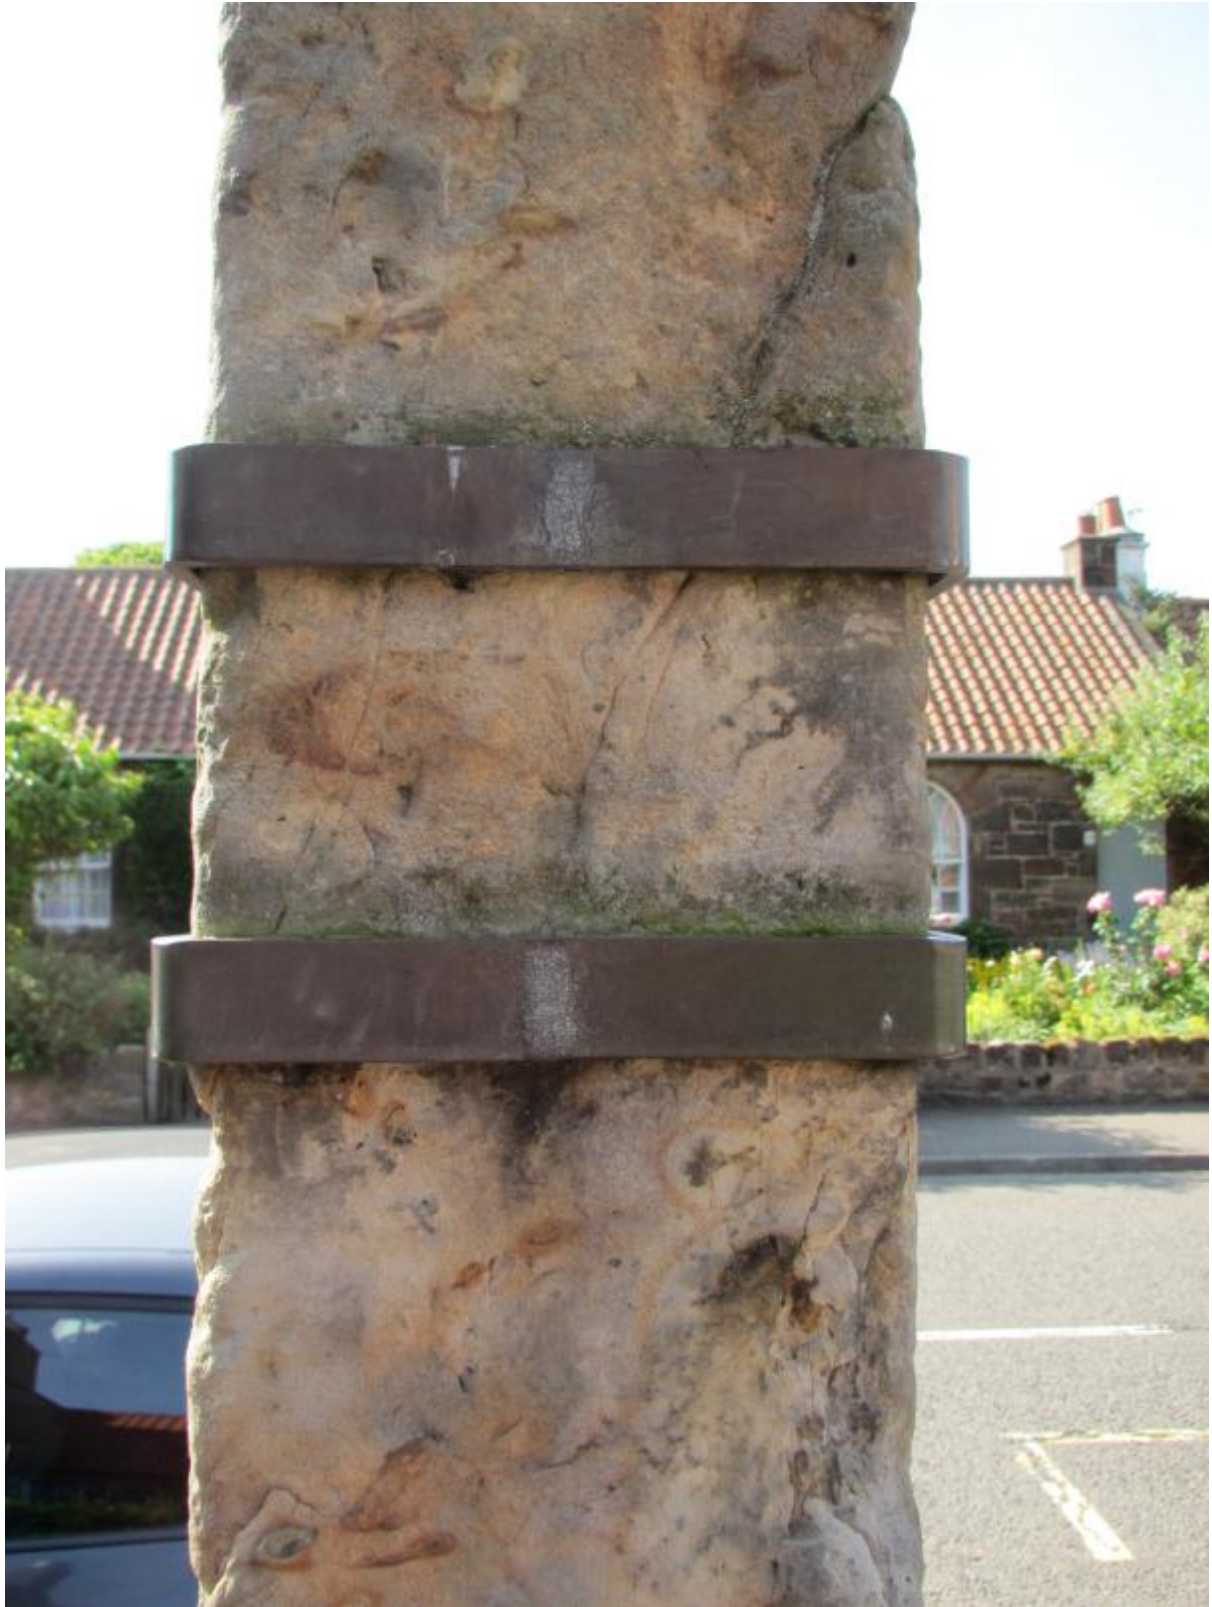
The north elevation of the shaft displays the most evidence of stone loss and much of the original surface has been eroded. There is also contour scaling following the natural sedimentary beds of the stone and at the corner of the west elevation this manifests itself as open fractures.

North elevation

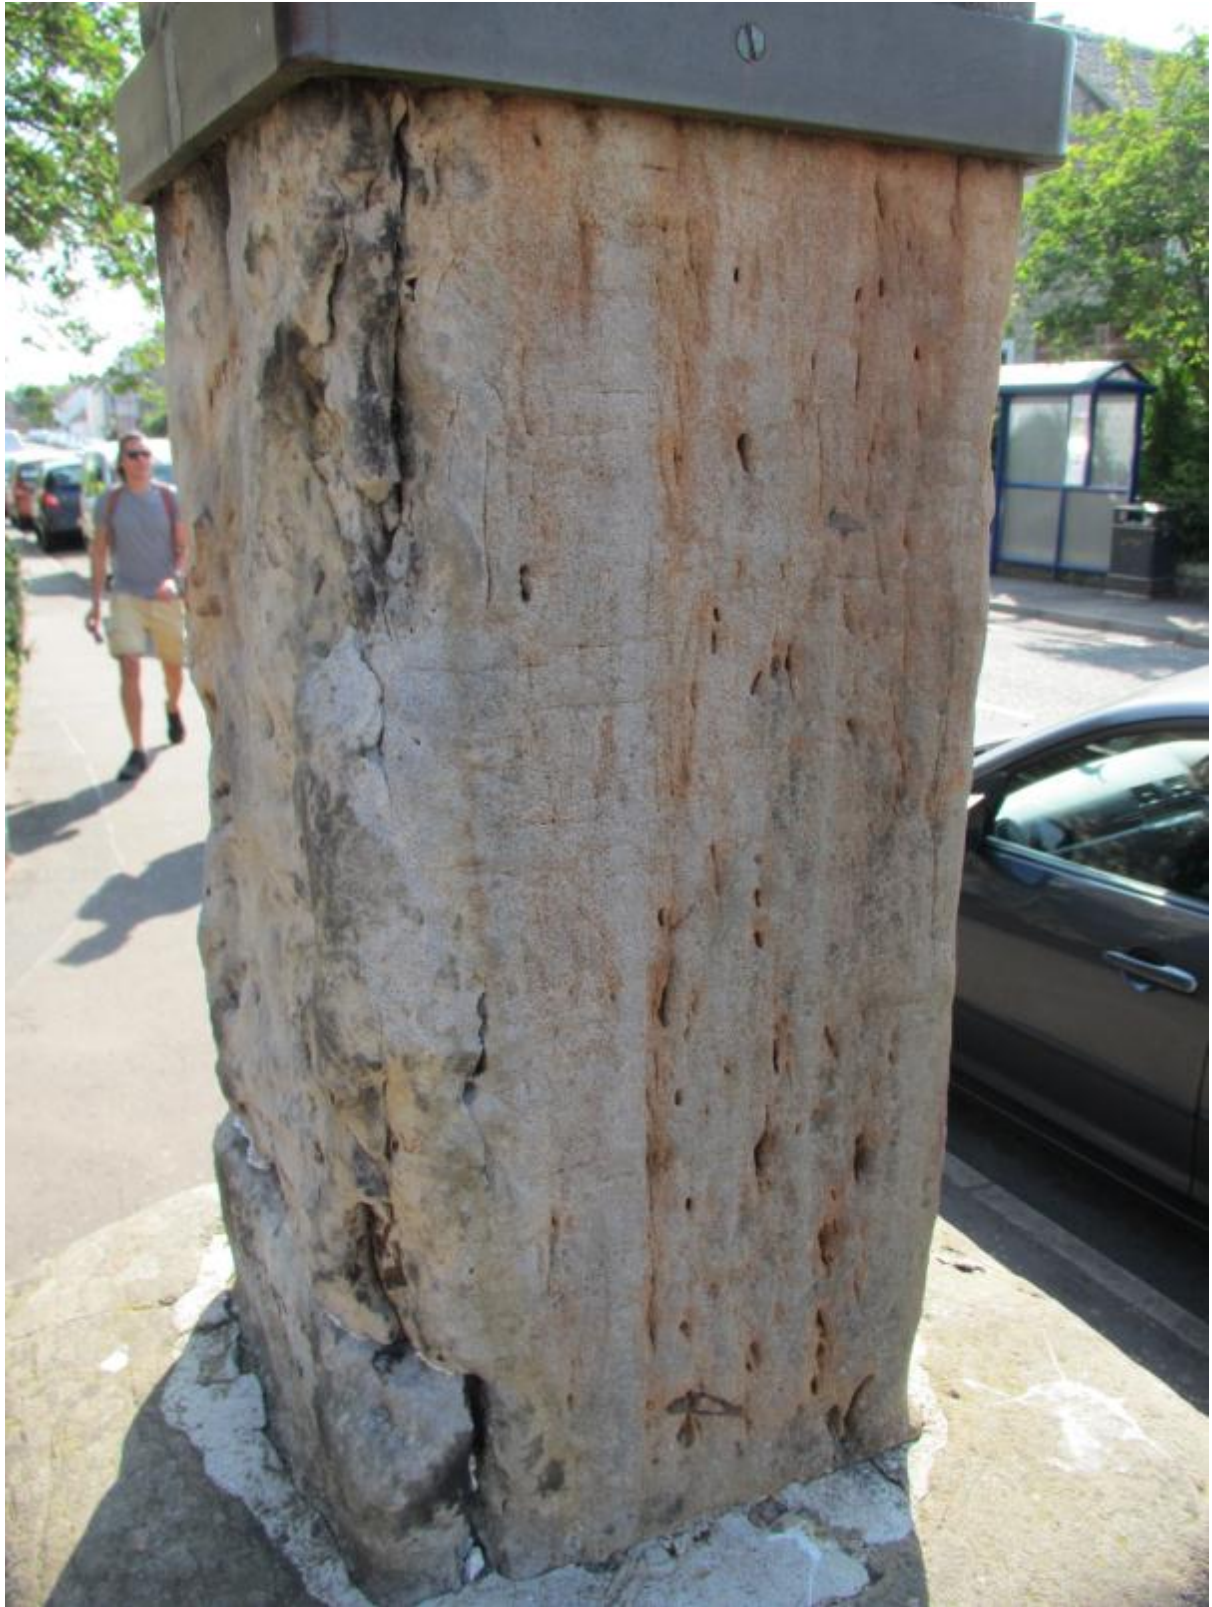
North West corner

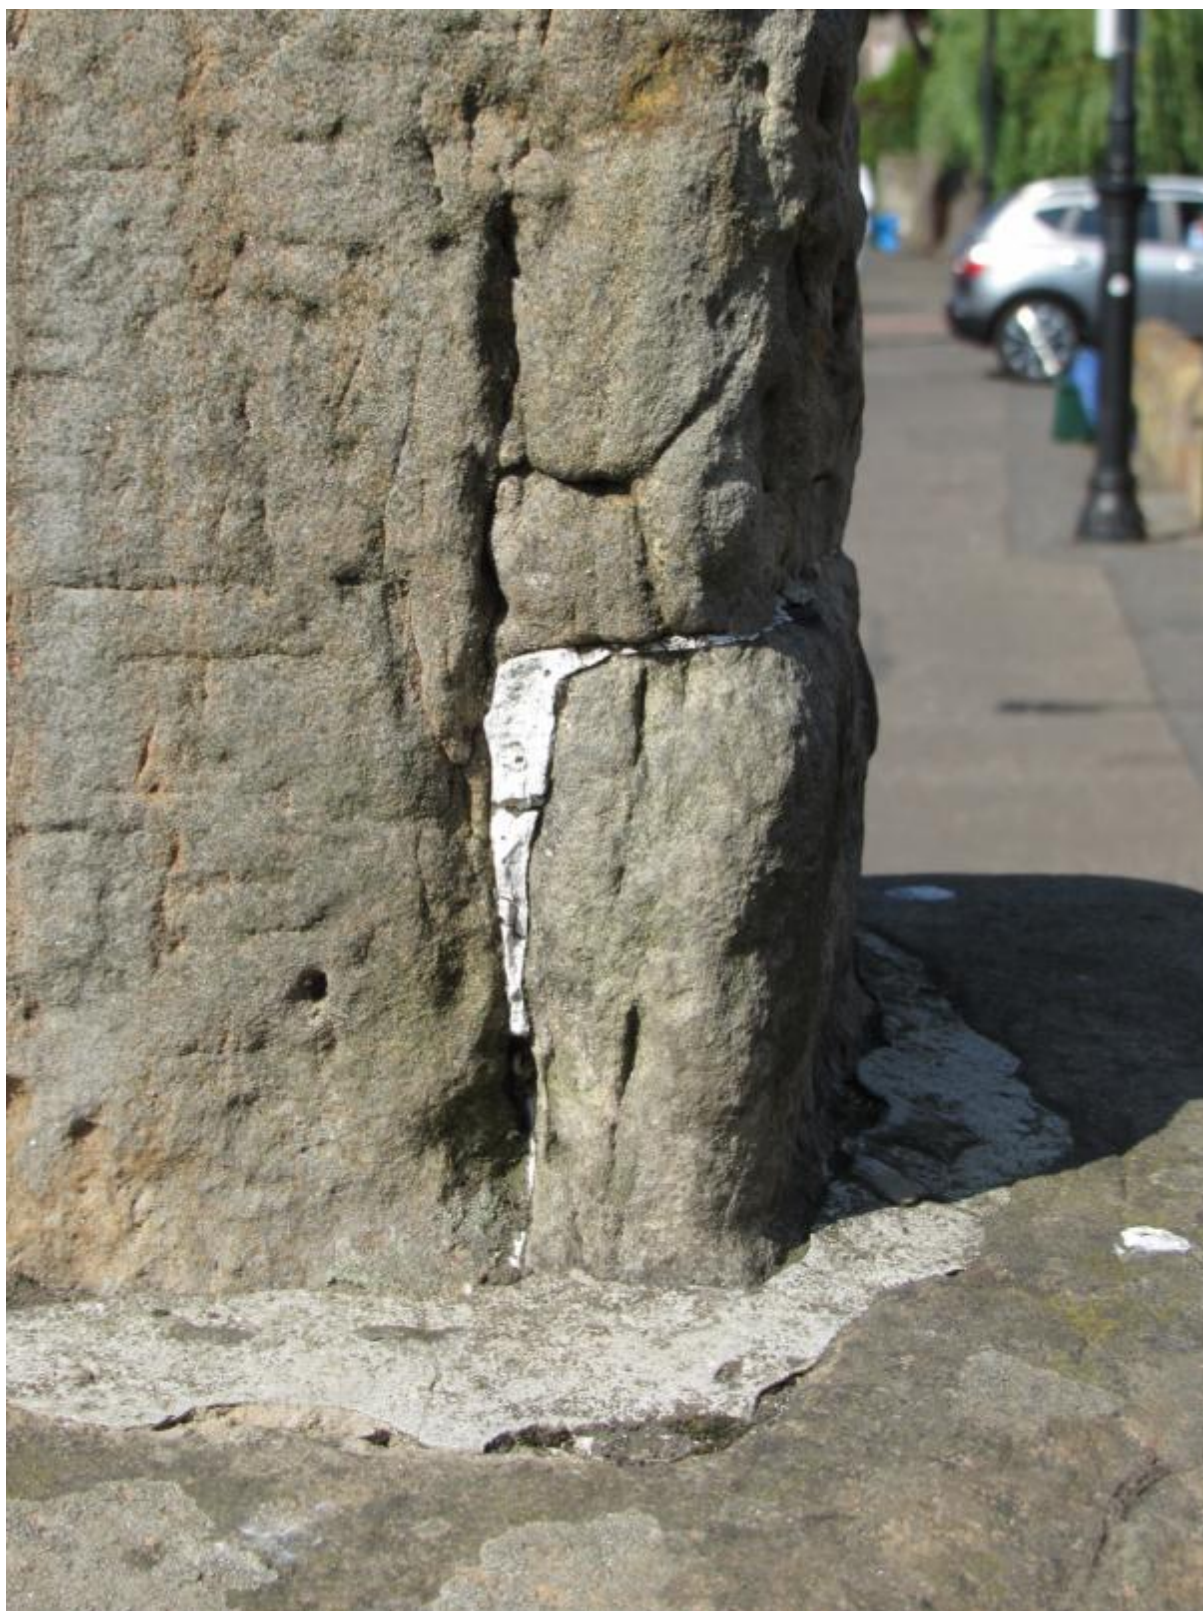
Indent viewed from the east

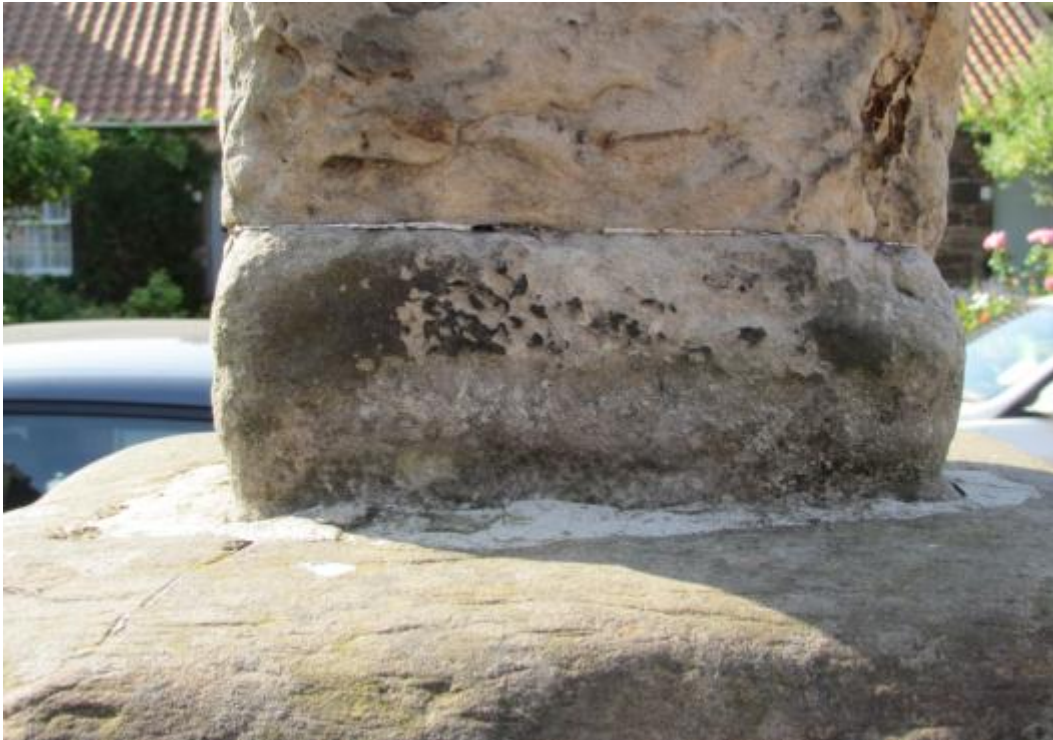
Indent viewed from the north

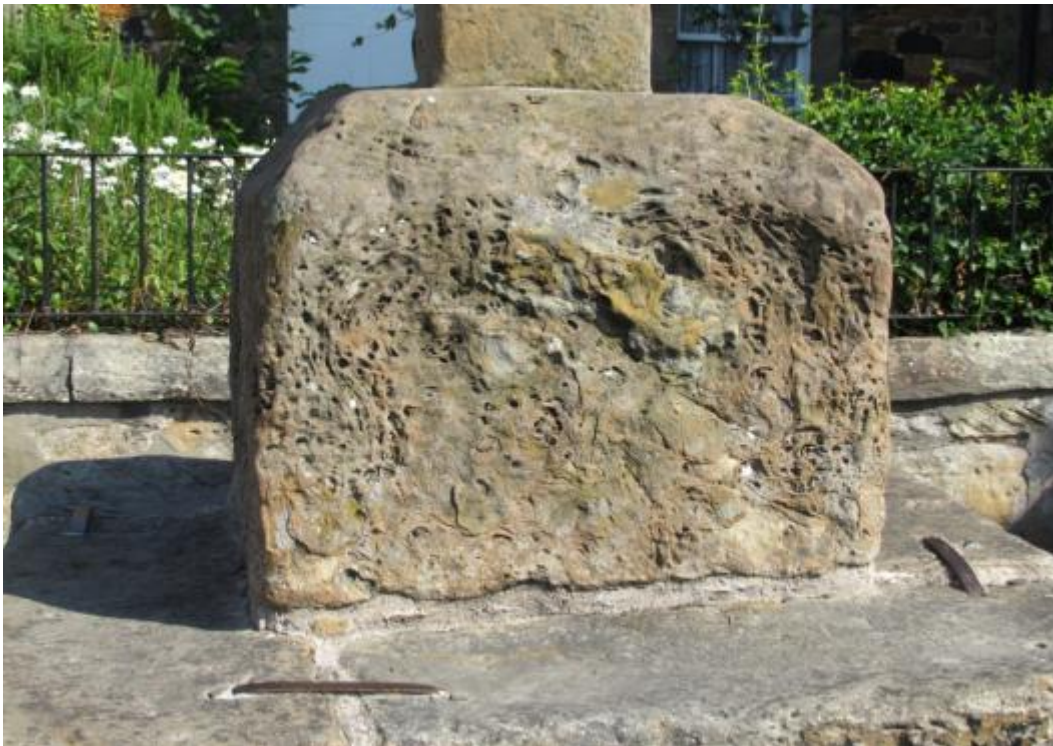
The plinth stone for the shaft is quite weathered but remains sufficiently stable to provide solid support for the shaft above. The stone is covered with numerous pits of varying sizes some of which have been previously filled with lime mortar. On the west elevation is a larger bedding fracture where softer material has weathered away however the loss appears

Plinth viewed from the south

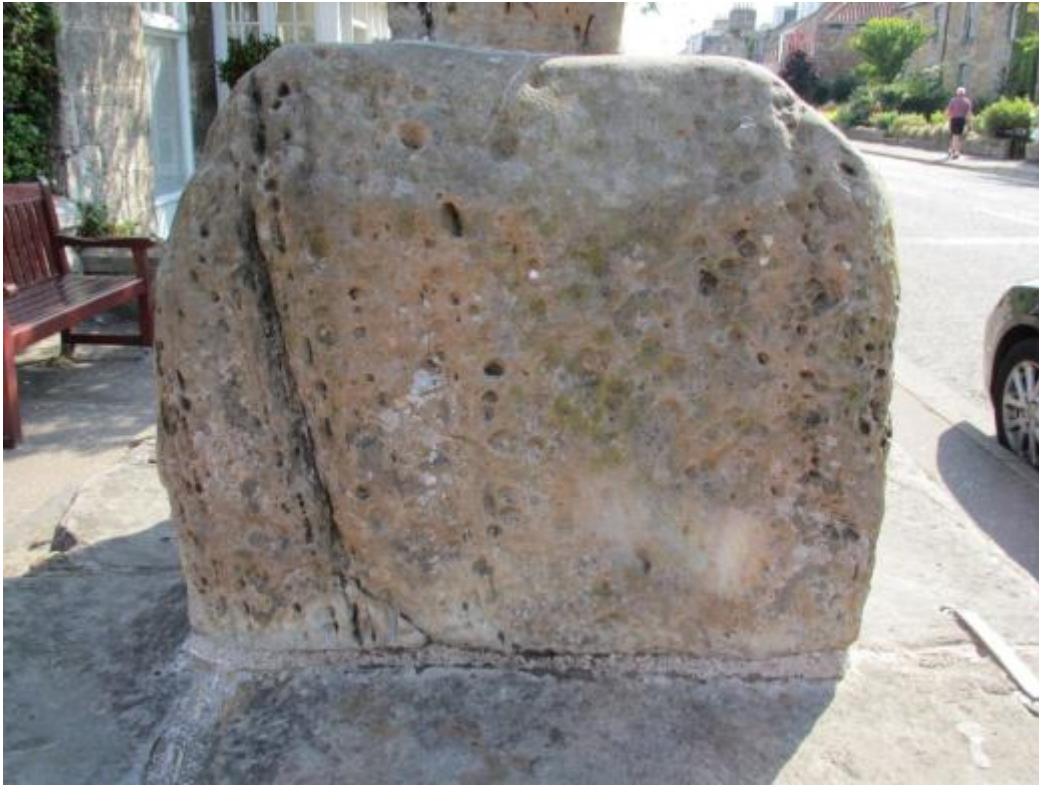
Plinth viewed from the west

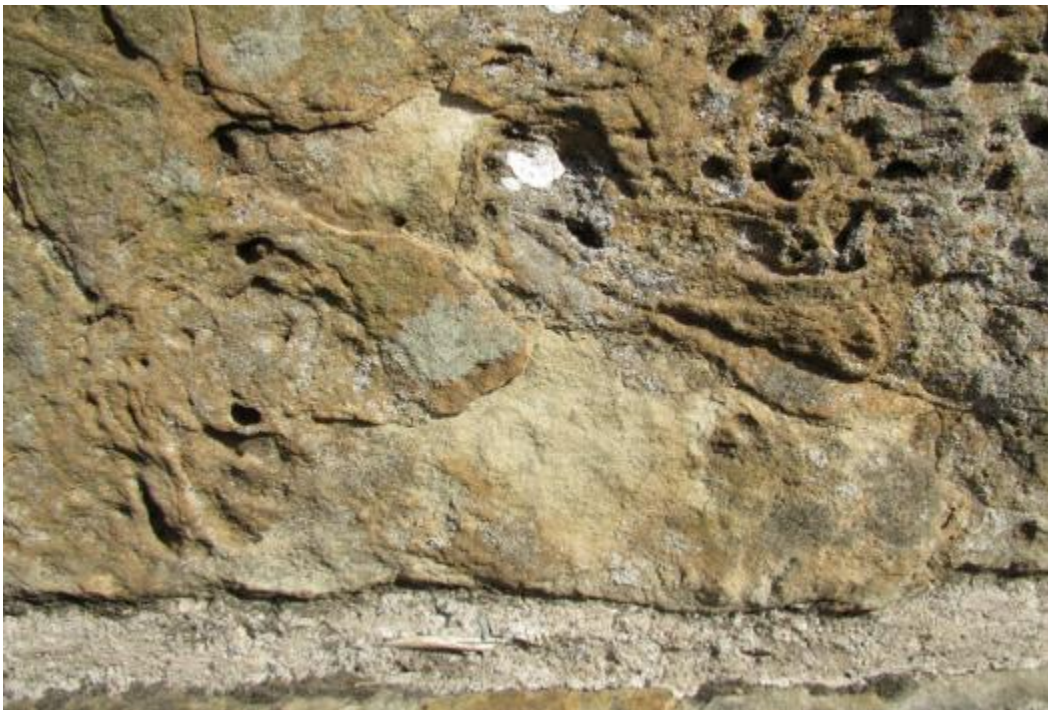
mainly superficial. On the south and north elevations there has been some recent loss from the lower parts of the plinth stone. These areas of delamination following the sedimentary bedding appear to be where feet of pedestrians sitting on top of the plinth stone have abraded the surface.

Lower south side of the plinth showing recent loss

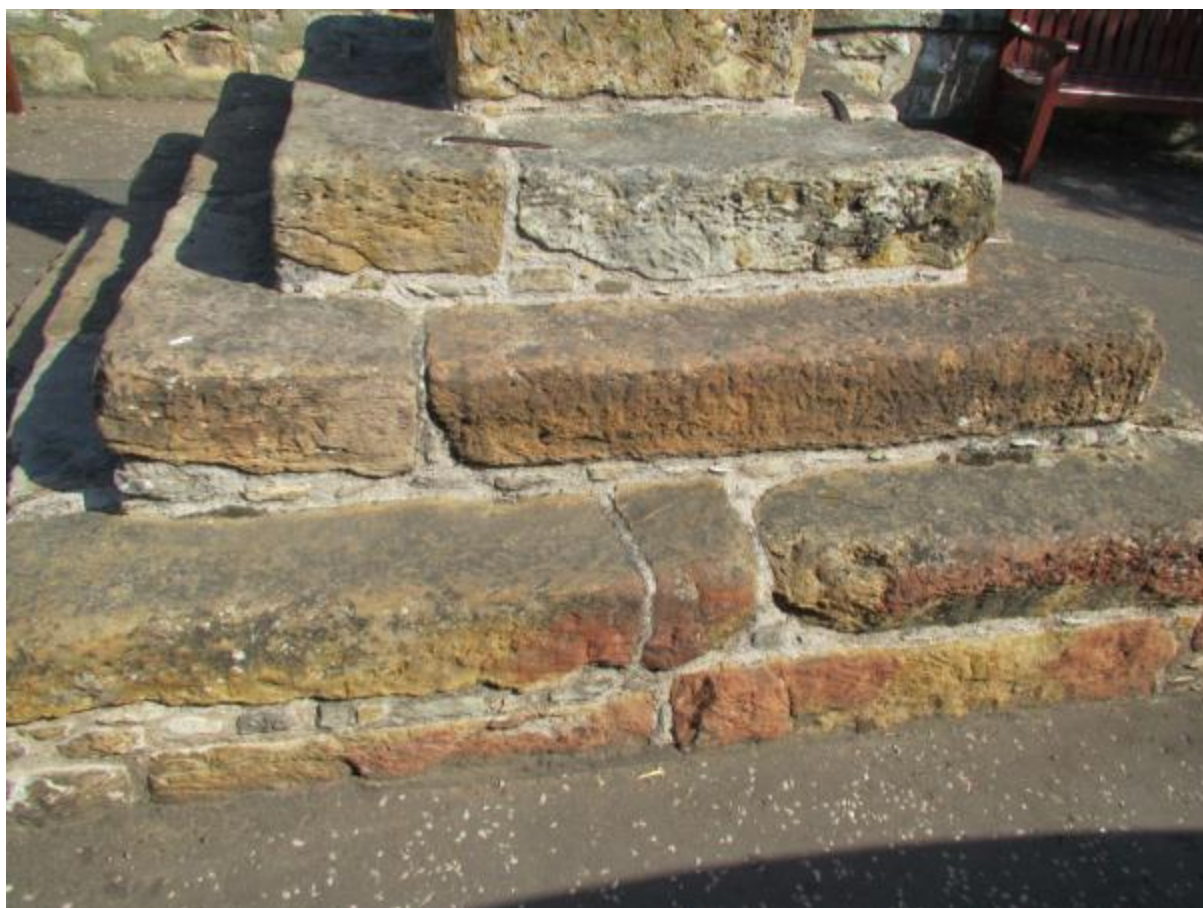
The steps supporting the plinth and cross shaft are structurally stable obviously helped by the previous repointing exercise. The iron cramps are secure and display no evidence of possible oxide jacking to the surrounding stonework. Some accumulation of soiling on the steps has allowed moss to become established however growth is minimal and not of any consequence at present. On the riser of the top course of steps on the south side is an area of fracturing and damage again possibly aggravated by pedestrians feet abrading the surface? On the lowest stepped course of this elevation is further fracture damage and potential for future loss.

Steps viewed from the south

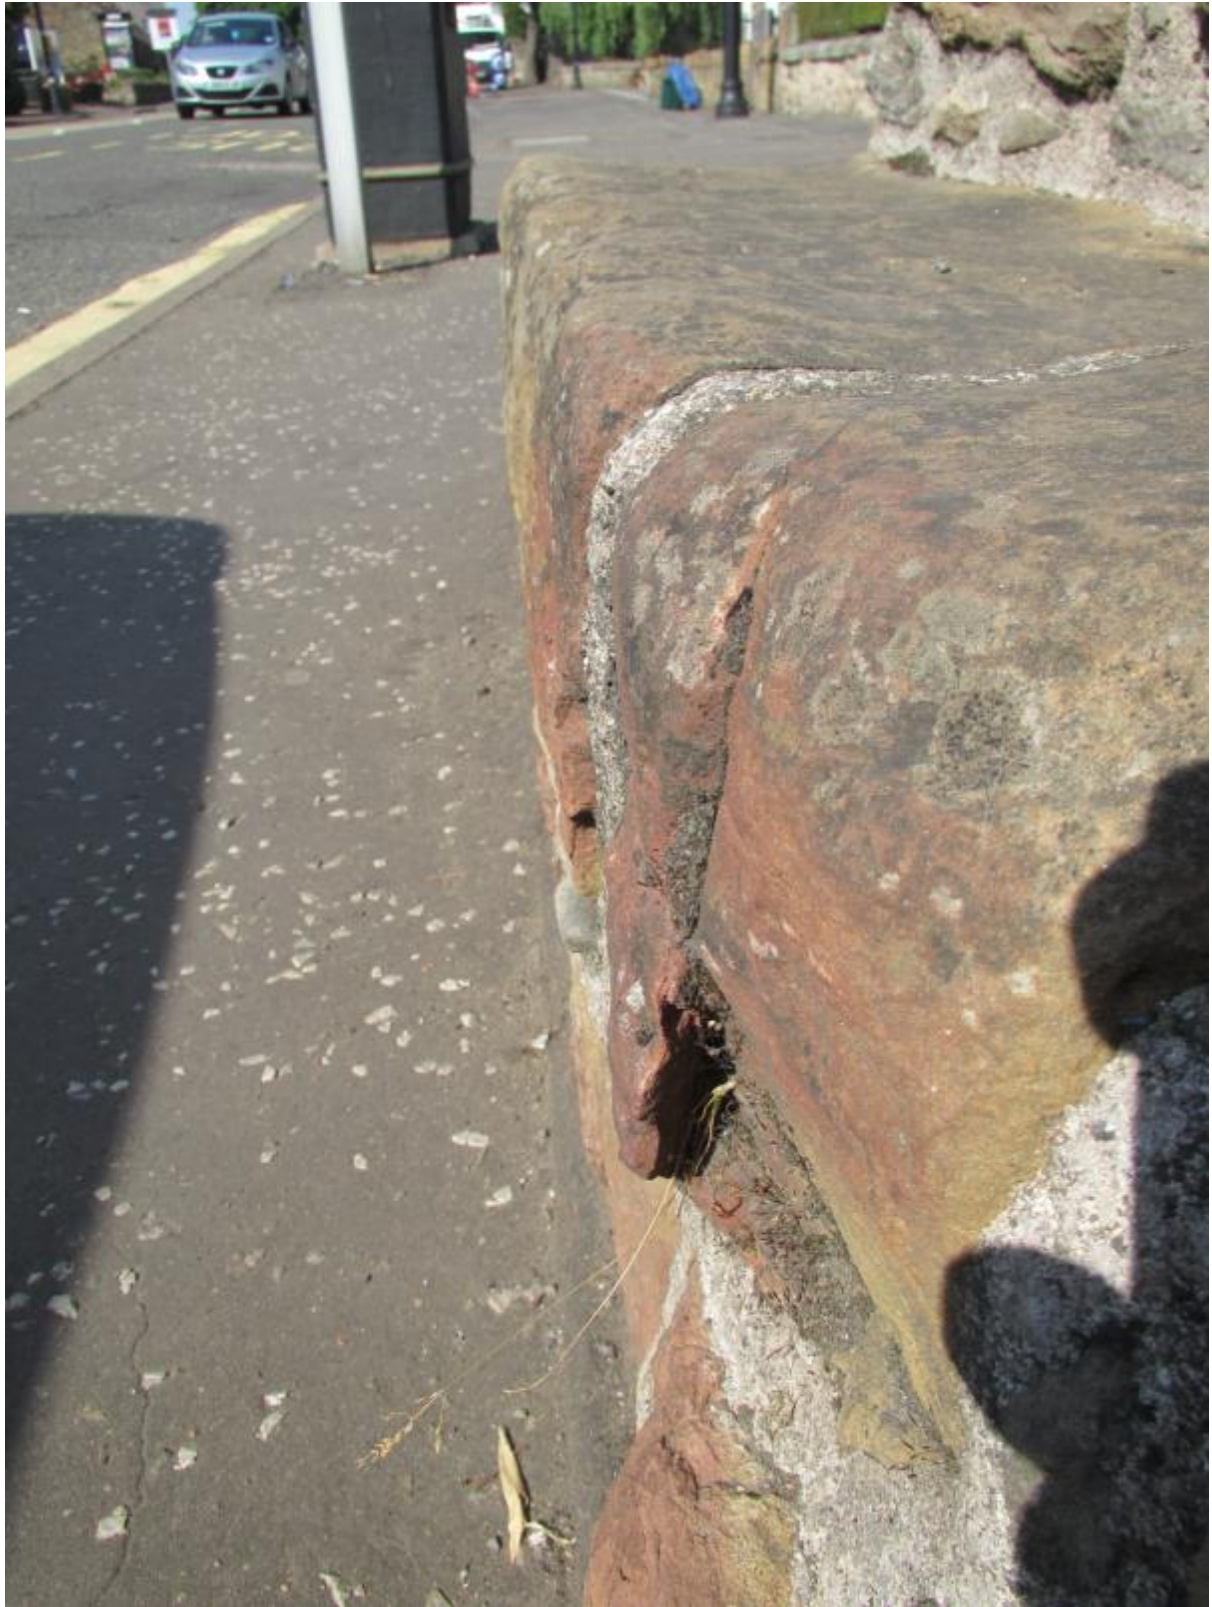
South side of the steps and area of damage

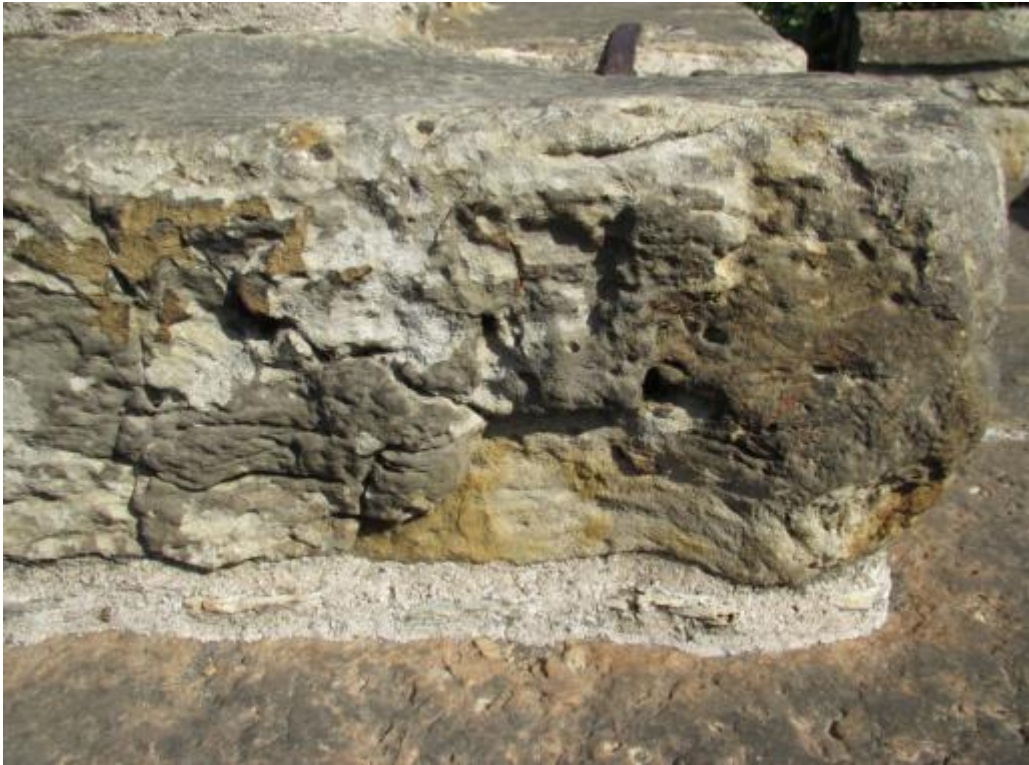
South side of upper step showing friable area

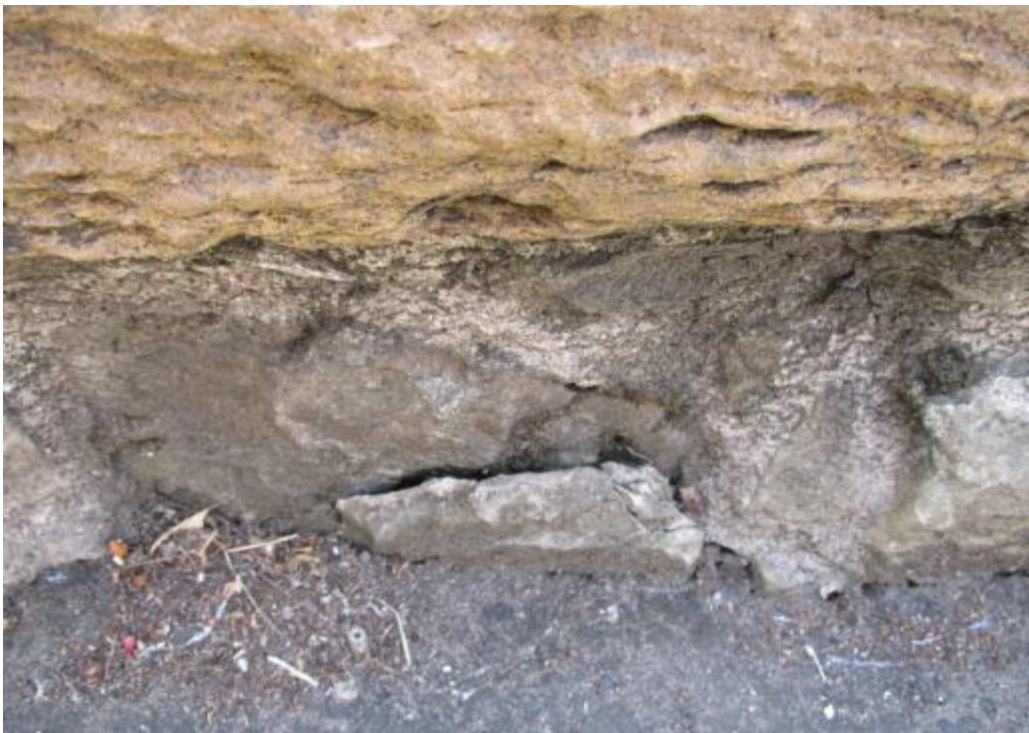
North lower step and detached fragment

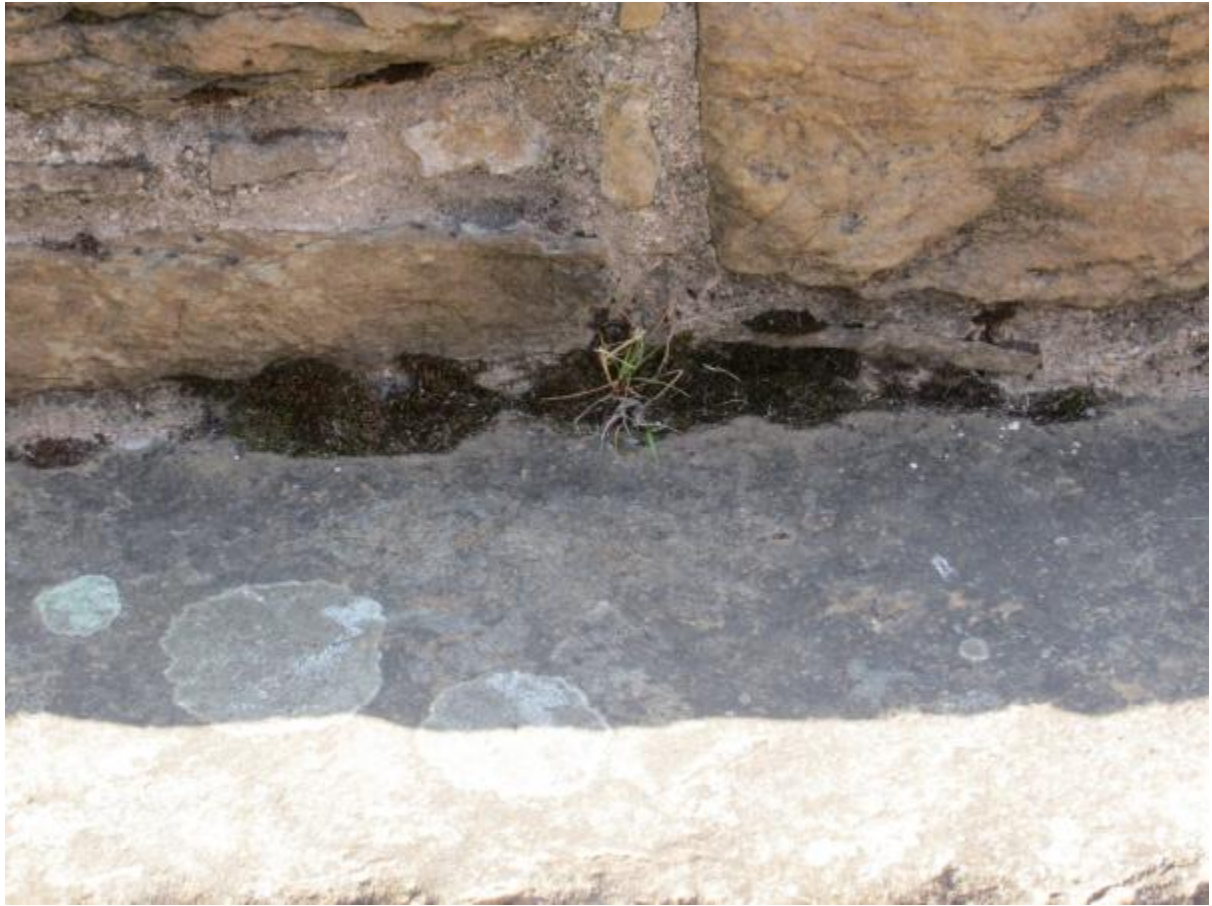
Superficial biological growth of the steps

- Biological growth is minimal and it should be sufficient to monitor this for now.
- Areas of open fracturing identified should be pointed using an acrylic mortar of a consistency and strength sympathetic to the stone.
- Only areas of very deep pitting where water might accumulate or where the stone is unstable should be filled to prevent further decay. This should not be extended to all areas of pitting as this is characteristic of this stone type and not necessarily a cause for concern.
