**CFA ARCHAEOLOGY LTD**

September 2008

**Aberlady Pier  
Aberlady, East Lothian  
Archaeological Excavation**

**Report No. 1561**

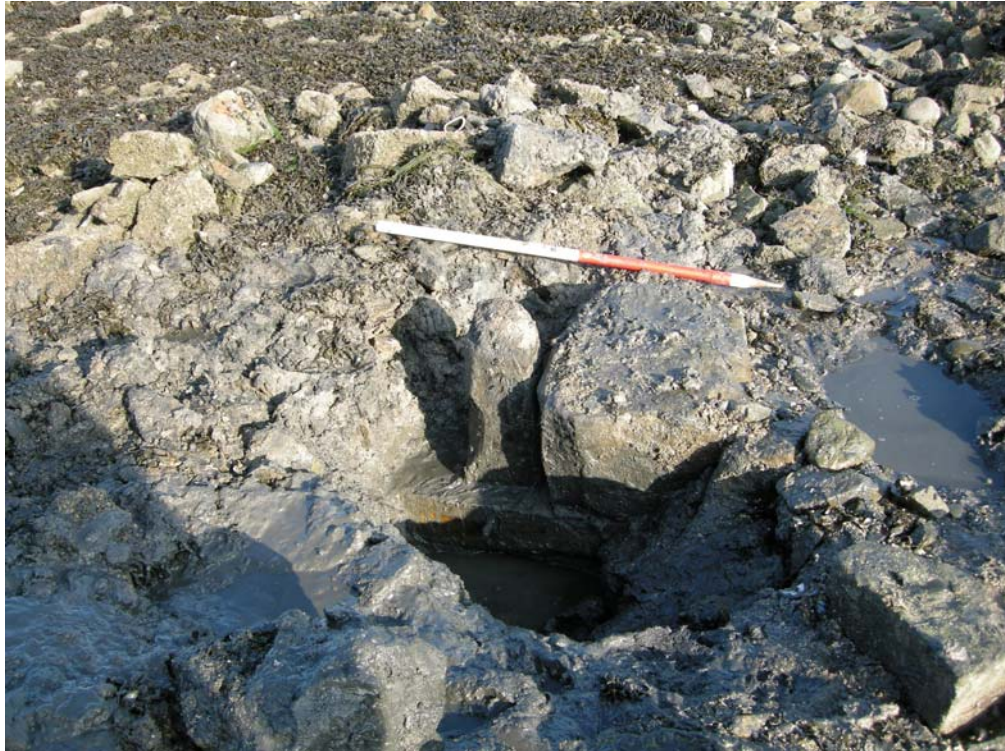
*Plate 1 Section of the harbour sleeper beam (409), pile (412) and large block of stone (405) in-situ*

A section of timber comprising of a section of a sleeper beam (409) and pile (412) was obtained from Trench 4 - near the end of the terminus of the pier. The timber was sampled to assess its species and potential use for dendrochronological dating. The pile and sleeper beam were found with associated revetment stone (Plate 1). Two saw cuts placed on each side of the pile ensured recovery of both the sleeper beam and pile.

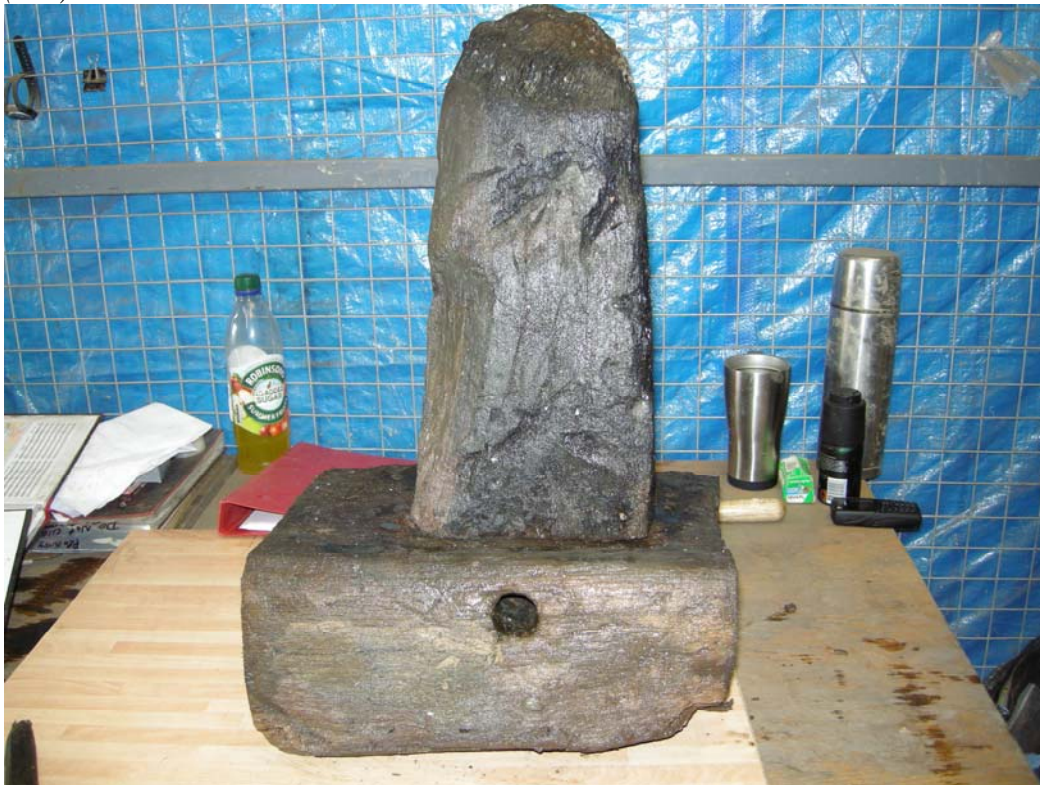
*Plate 2 Sleeper beam (409) and pile (412) prior to dismantling (top of the pile is eroded)*

The sleeper beam and pile have been fixed together using a mortis and tenon joint, and held in place using a tree-nail or oak peg that was hammered into a hole that was drilled through the side of the sleeper-beam. The mortis socket measured 160mm by 70mm and was 160mm deep. The mortise joint measures 120mm deep and 150mm wide. The hole has a diameter of 35mm.

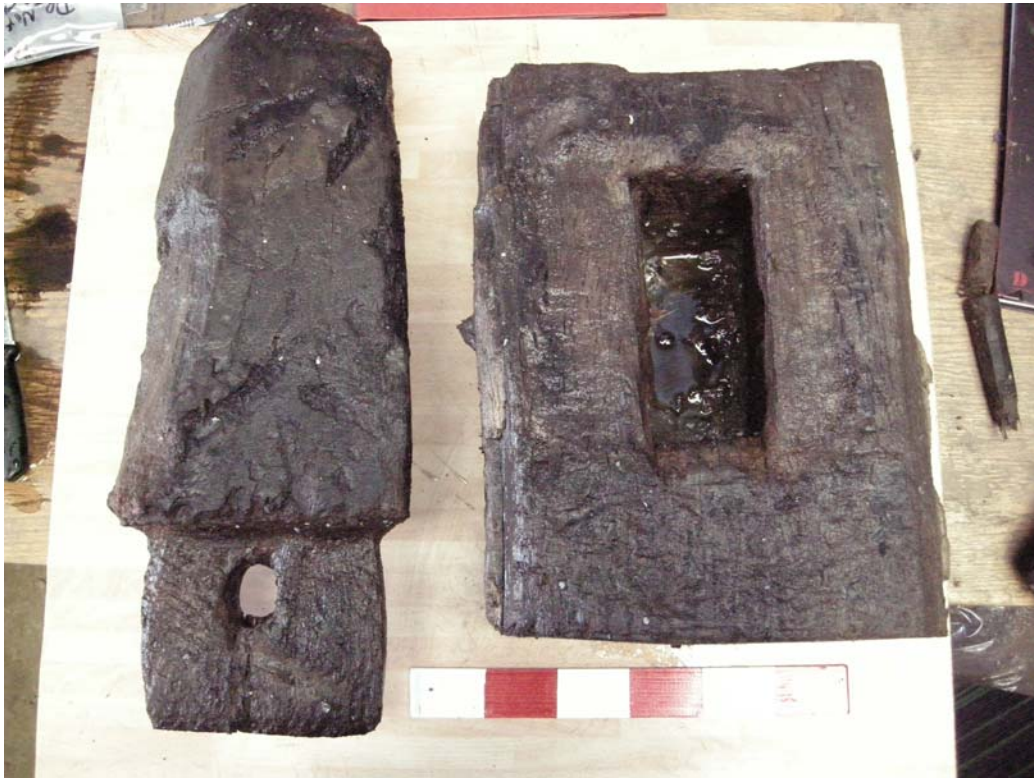
*Plate 3 The tenon joint on the end of the pile (412) and the mortis socket in (409) following dismantling*

The mortis socket was cut out using a chisel and this has left crude marks at the base. The sides are near vertical and very smooth. The weight of the pier deck has resulted in a distinct compression mark around the mortis hole (Plate 3). The sleeper beam has been hewn by radially splitting a large diameter trunk. The timber was then hewn more or less to a rectangle. Both the heart and sap-wood are present within the sleeper beam. The sapwood is the lighter coloured wood at the base of the beam.

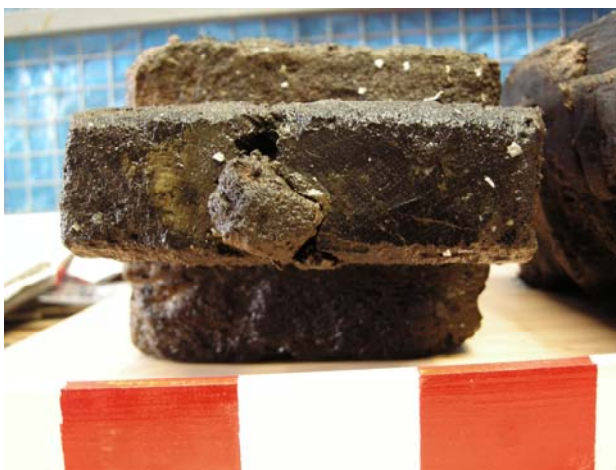
*Plate 4 Small wooden fillet hammered in a crack at the end of the mortis joint and tree-nail (411).*

At the terminal end of the tenon joint, a small wooden fillet had been hammered into a crack in order to expand the joint and make it a tighter fit within the mortis hole. The fillet is oak (Plate 4).

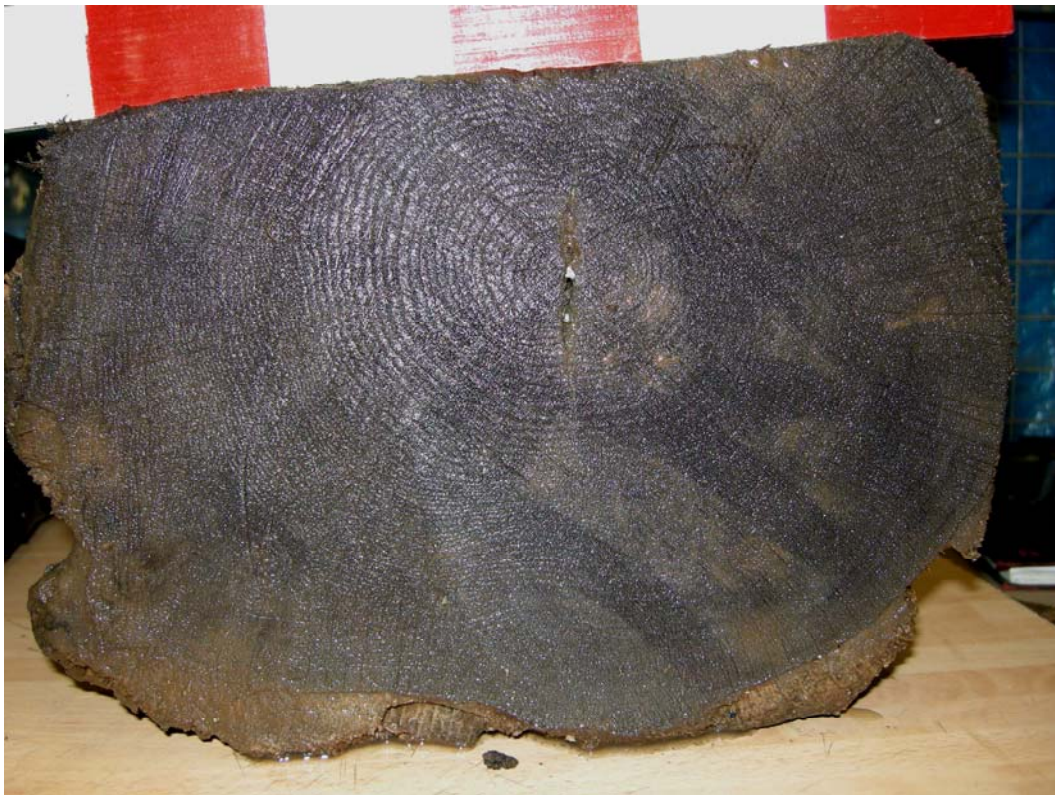
Plate 5 Heart and sapwood in the sleeper-beam timber.

The sleeper-beam (Plate 5) contains in excess of 100 annual rings with an estimated sap-wood growth pattern of +25 annual rings present. The tree ring sequence displays rapid growth in its first thirty years, after which there is a considerable slowing down of its growth patterns. The pile will need to be sectioned above the tennon joint and a tree-ring count of well over 50 annual rings is estimated.

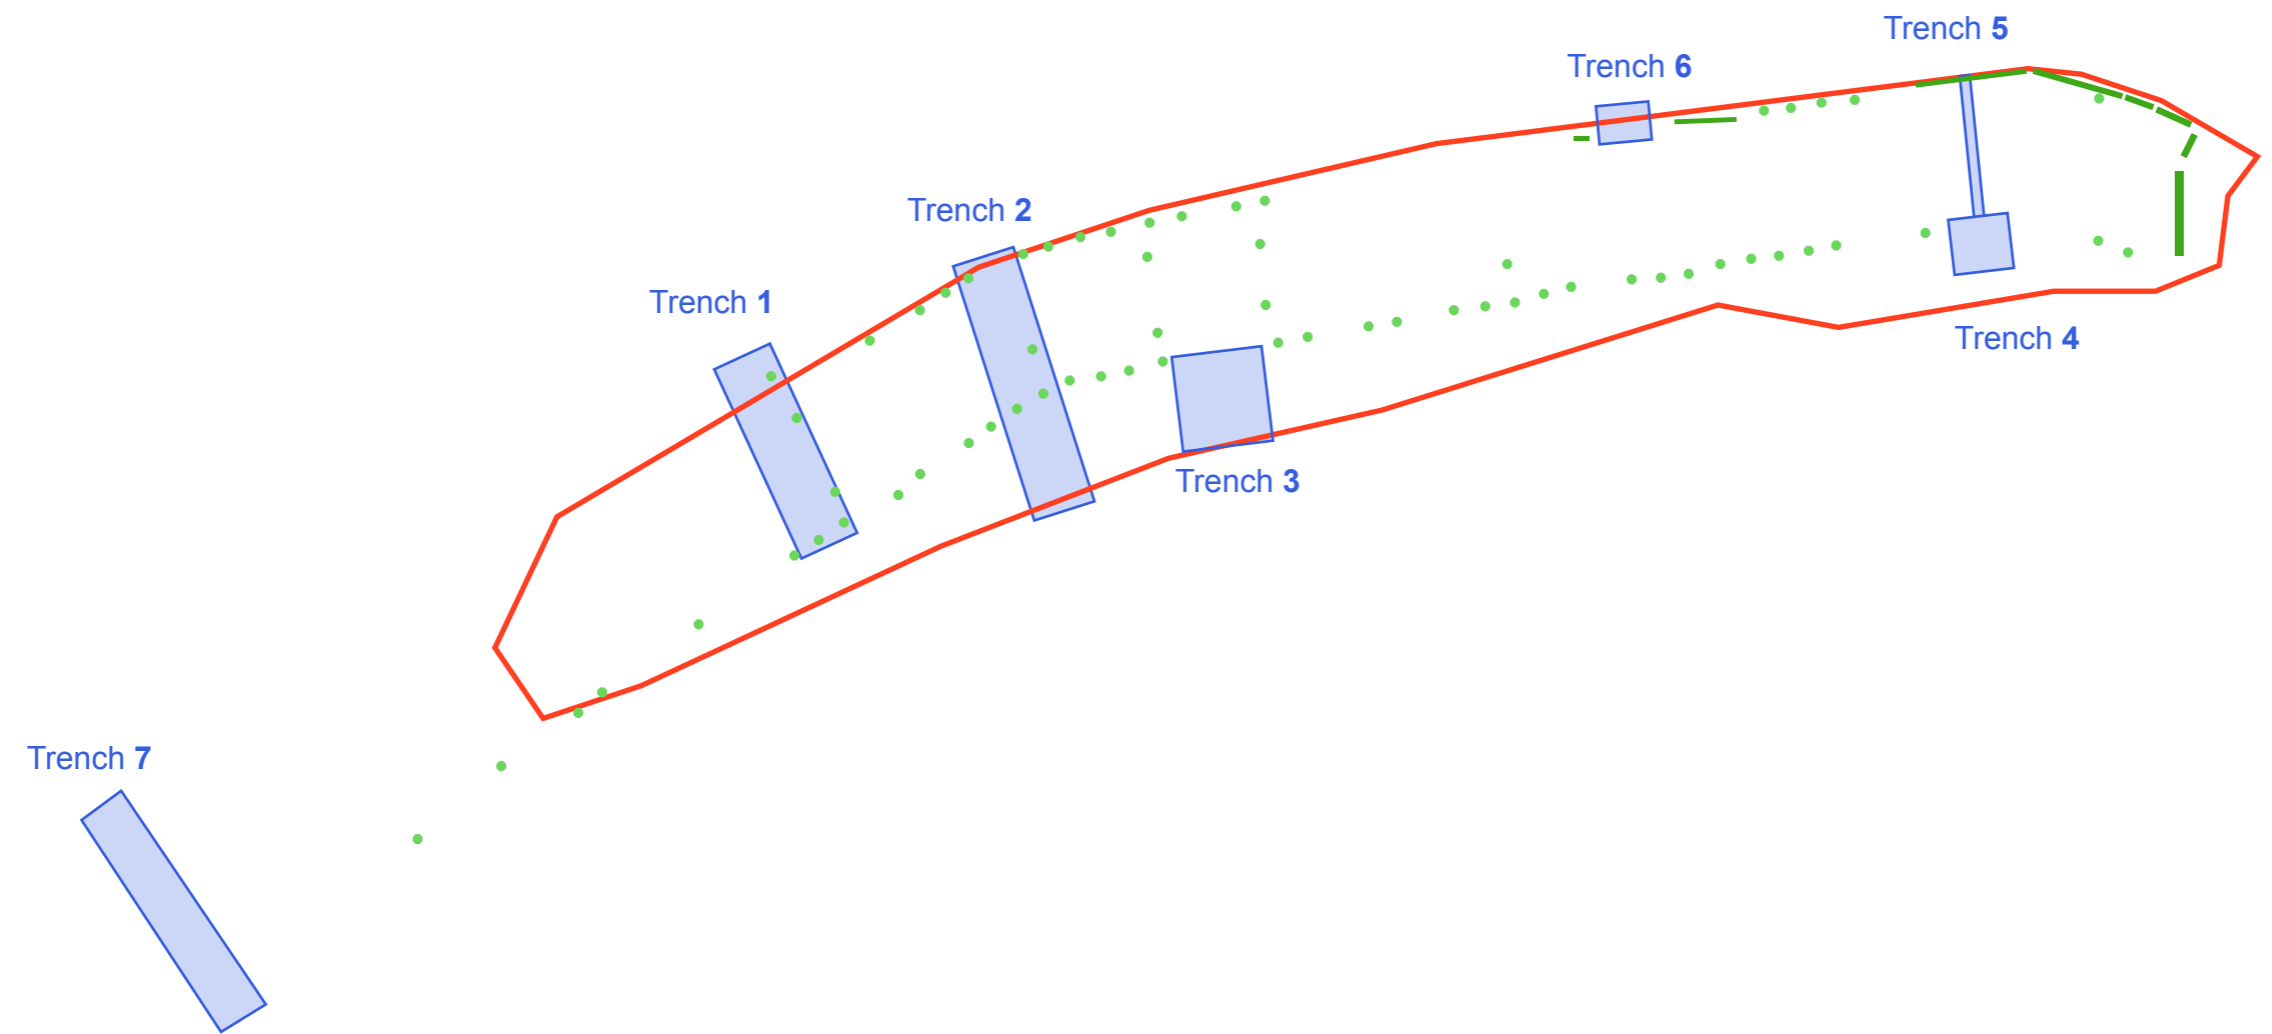
Fig. No:	<b>2</b>	Revision:	<b>A</b>
----------	----------	-----------	----------

- Upright Timbers
- Planks
- Trenches
- Outline of Pier

Title:  
**Trench Locations**

The total area excavation was 52m<sup>2</sup>. Seven trenches were excavated spread over the pier (Figure 2). Six trenches (Trenches 1-6) were excavated over the exposed pier remains, a further trench (Trench 7) was placed to assess if the pier remains extended towards the Custom House. Trench positions were surveyed with industry standard survey equipment (Total Station).

Seven trenches totaling 52m<sup>2</sup> were excavated by hand (locations shown on Figure 2). Context numbers are in bold and a full list is provided in Appendix 1.

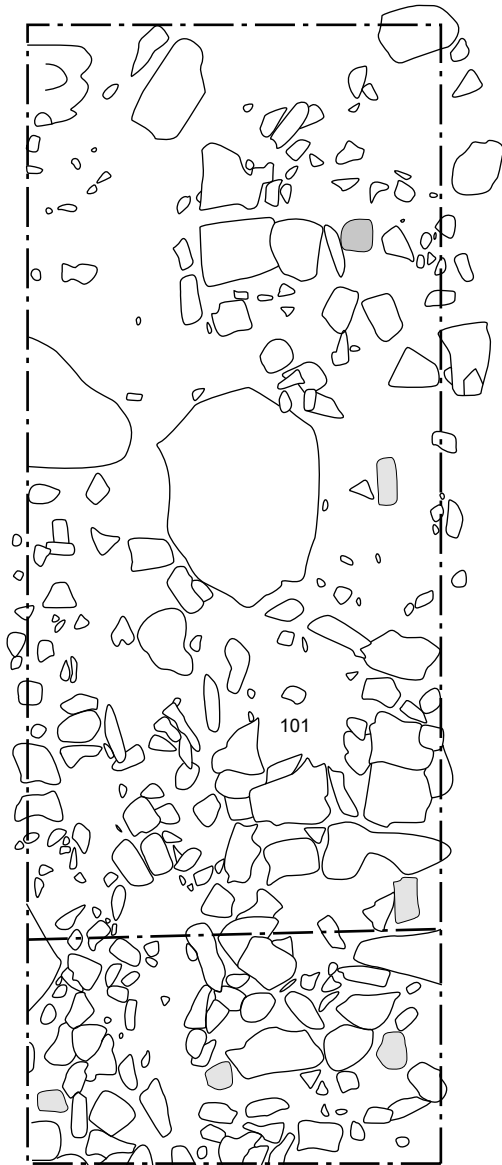
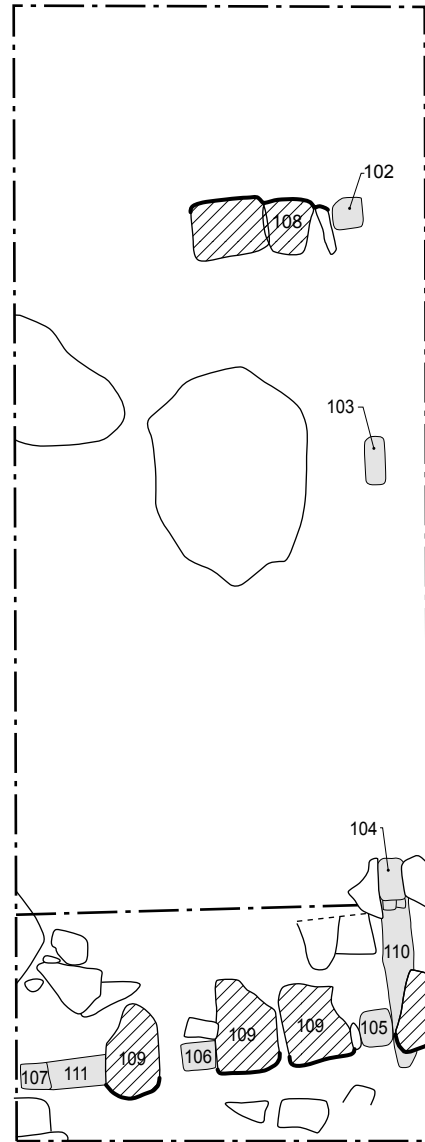
Fig. No:	<b>3</b>	Revision:	<b>A</b>	Client:	Aberlady Conservation Society
Title: <b>Trench 1 - Pre - Excavation and Post-Excavation Plans</b>					
Project: <b>Aberlady Pier, Aberlady, East Lothian: Archaeological Evaluation</b>

Pre-Excavation Plan

Post - Excavation Plan

Trench 1 was placed over the south west area of the structure. Sand and rock overburden (**100**) was removed to reveal a grey shell sand (**101**). Six posts and an associated longitudinal sleeper beam (**110**) were present. The remnants of the north and south stone walls were also identified. Posts (**105**), (**106**) and (**107**) were positioned within the southern wall (**109**). The possible remnants of the northern wall (**108**) were also recorded associated with a wooden post (**102**). (**101**) contained numerous finds (discovered through metal detecting) of post-medieval and modern date.

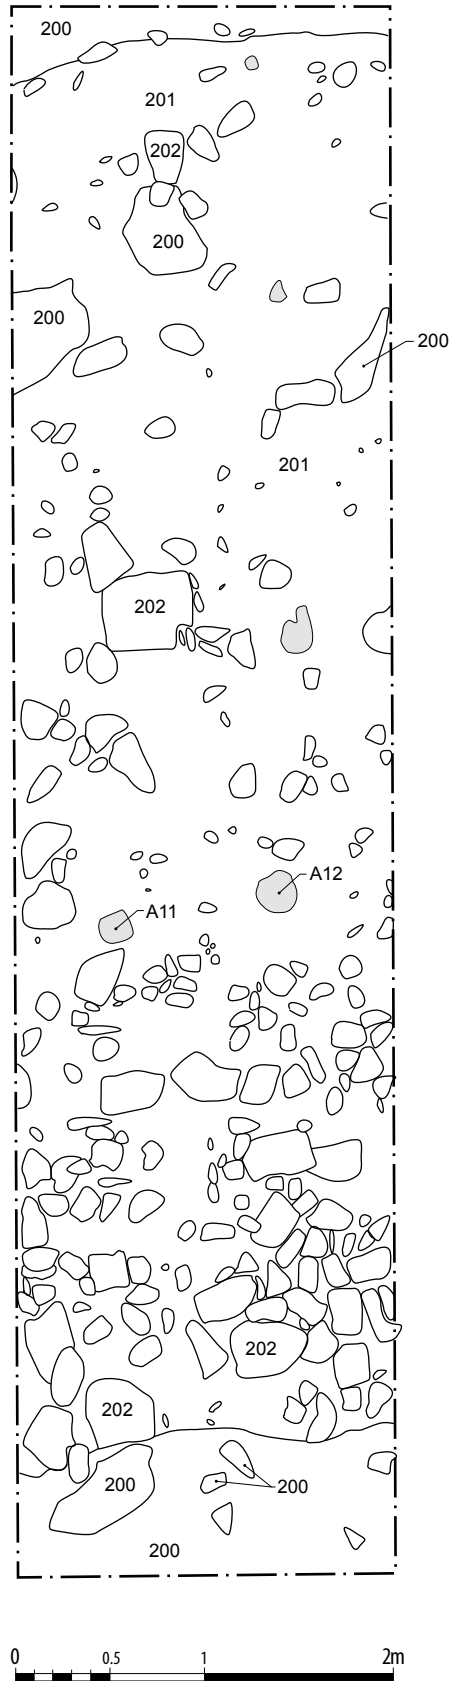
Fig. No: **4** Revision: **A** Client: **Aberlady Conservation Society**

Title:  
**Trench 2 - Pre-Excavation Plan**

Sand and rock overburden (200) was removed to reveal grey shell sand and rock (201) and large stone boulders (202). Trench 2 revealed two posts (A11) (A12), which when viewed in section were set at an angle, away from the vertical. No associated walls were detected. Trench 2

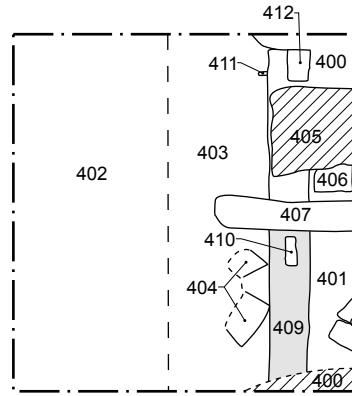
Trench 4 - Post-Excavation Plan

Trench 4 was placed on the east area of the structure and revealed sections of wall with associated timber posts. Sand and rock overburden (400) was removed to reveal grey shell sand and rock deposits (401). A sleeper beam (409) was recorded with a rectangular 'notch' (410) - a mortice and tenon joint for an upright post (now missing). A wooden peg (411) protruding from the sleeper beam (409) secures an upright pile (412). The upright pile (412) when viewed sideways is set at an angle, away from the vertical. The sleeper beam (409) was, in turn, fixed to another sleeper beam (407) with a square wooden peg (408). A sample of (409), (412) and (411) was taken for dendrochronological dating and is discussed below.

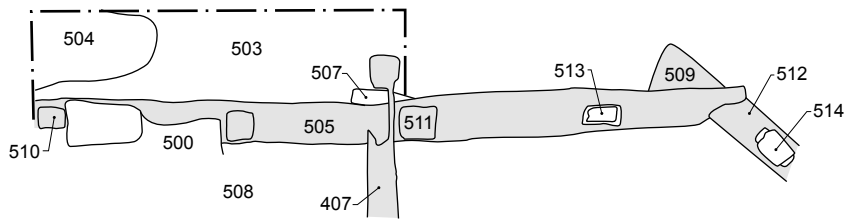
Trench 5 - Plan of Exposed Planks

Sand and rock overburden (500) was removed to reveal a grey shell sand and rock (501) and stone (502) deposit. A sleeper beam (505) running E-W was exposed at the east of the structure on the north side. A sleeper beam revealed in Trench 4 (407) was fastened onto (505) with a wooden peg (506) and a wooden wedge (507) was recorded associated with the checked joint between the planks (407 and 505). Two upright posts (508 and 511) were recorded within (505). A further sleeper beam (509) was connected by peg (512) to (505).

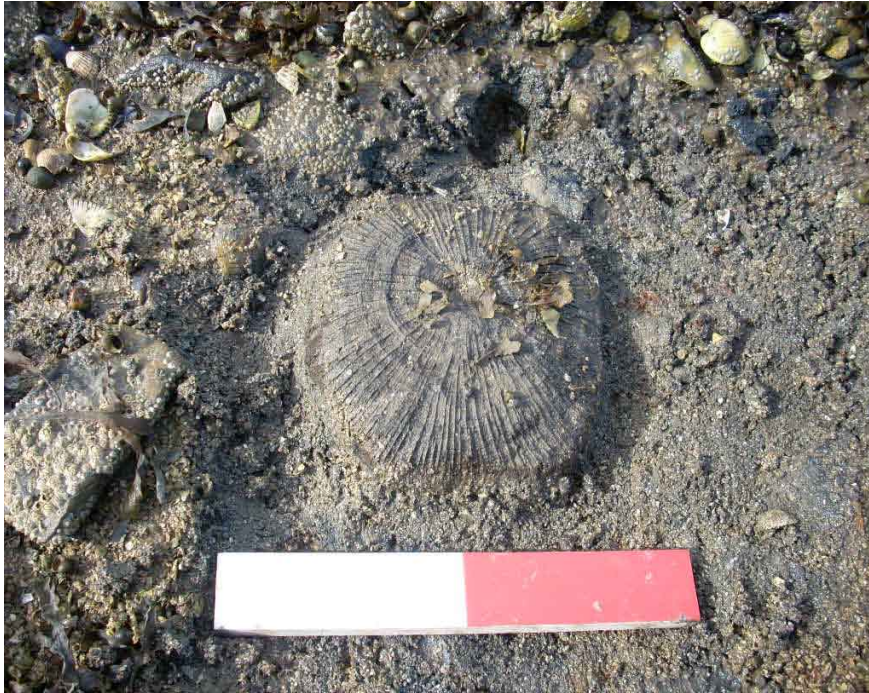
Plate 8 - Example of post within pier remains

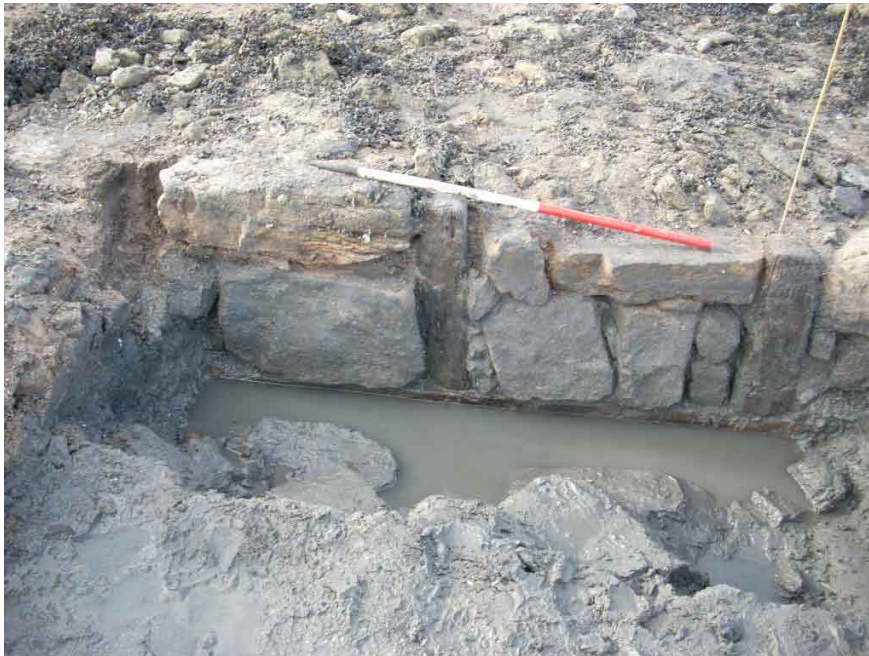
Plate 9 - Trench 3

Trench 3 was positioned within the middle of the pier remains. Sand and rock overburden (300) was removed to reveal a wall of large sandstone blocks (301). A large deposit of oval blocks (303) was also identified which may have been original infill material of the pier. Two posts (A23 and A24) were also found associated with the structures walls (301). A dark clay silty deposit (302), possibly a later silting event, contained pottery of 15<sup>th</sup> – 16<sup>th</sup> Century date.

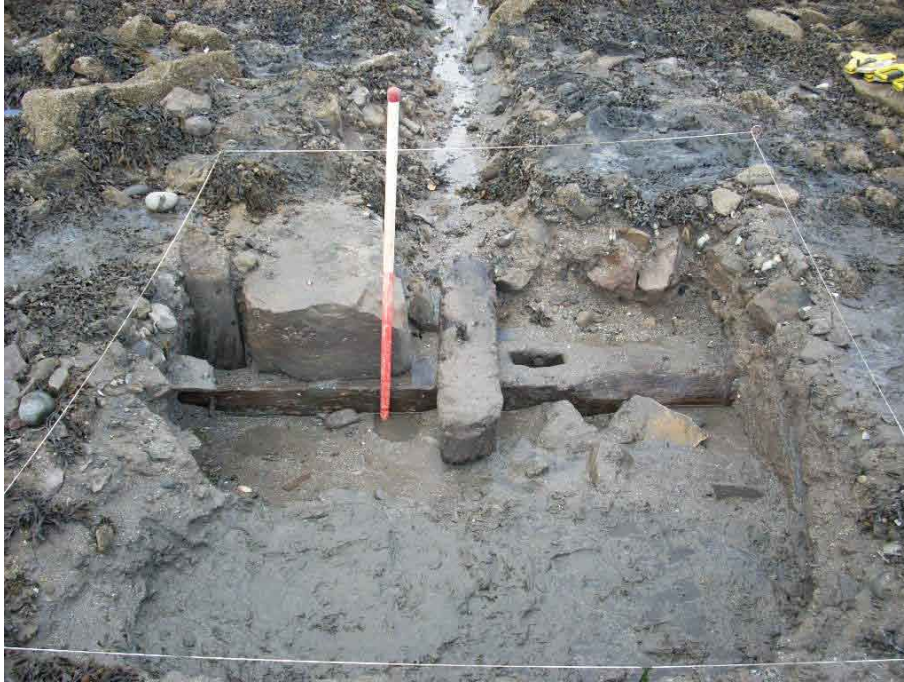
Plate 10 - Trench 4
