**The Smugglers Cave
Aberlady Bay
Aberlady, East Lothian**

**Archaeological Evaluation
Report No. 1616**

Author	Cara Jones BA
Illustrator	Leeanne Whitelaw BSc MAAIS
Editor	Tim Neighbour BSc FSA Scot MIFA
Commissioned by	Aberlady Conservation Society
Date issued	March 2009
Version	FINAL
OASIS Reference	
Grid Ref	NT 44983 80283

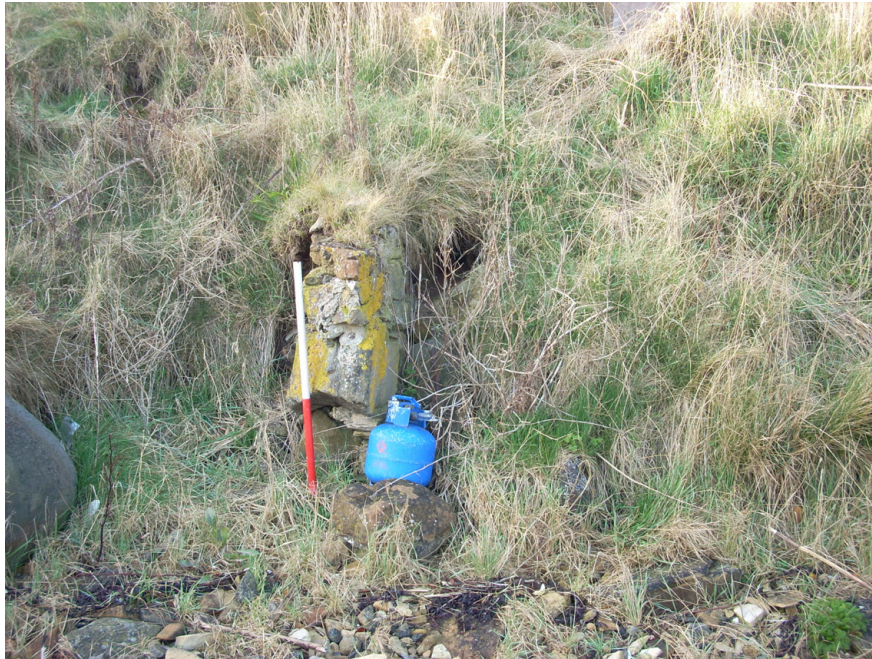
Figure 3: Wall 005 protruding from cliff edge, thought to be the location of the smugglers cave

Slot 2 (Figure 9a-b, 10b) was excavated to further expose the mortared stone wall **(005)** that could be seen in the cliff face pre-excavation (Figure 3). Natural yellow marine sand **(004)** was exposed at the base of the slot. This was overlain by a mid brown sand layer **(003)**. Two walls **(005** and **006)**, which were founded on this layer **(003)**, and form a passage 0.5m wide, which leads into the cliff face. The walls appear to have been constructed as revetments, to ensure that debris from the bedrock sides of the passage could not fall into the passage (Figures 5, 6 and 7). The space between the walls was filled by a deposit of mid brown sandy loam **(002)**, which also covered and sealed the tops of the walls.

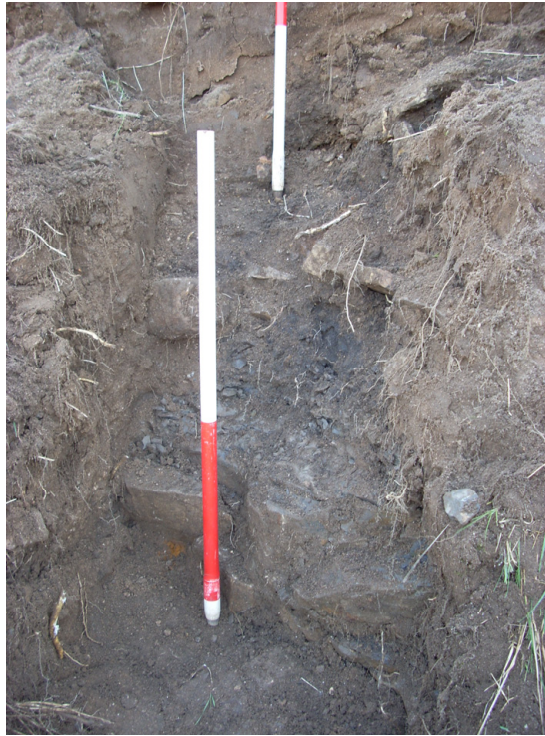
Figure 4: Slot 1 – post excavation shot

Slot1(Figure 9a-b, 10a) revealed a natural rock and shale outcrop beneath a dark brown sandy loam (**008**), which in turn underlay the mid-brown sandy loam (**002**). No features of anthropogenic origin were revealed in this slot (Figure 4).

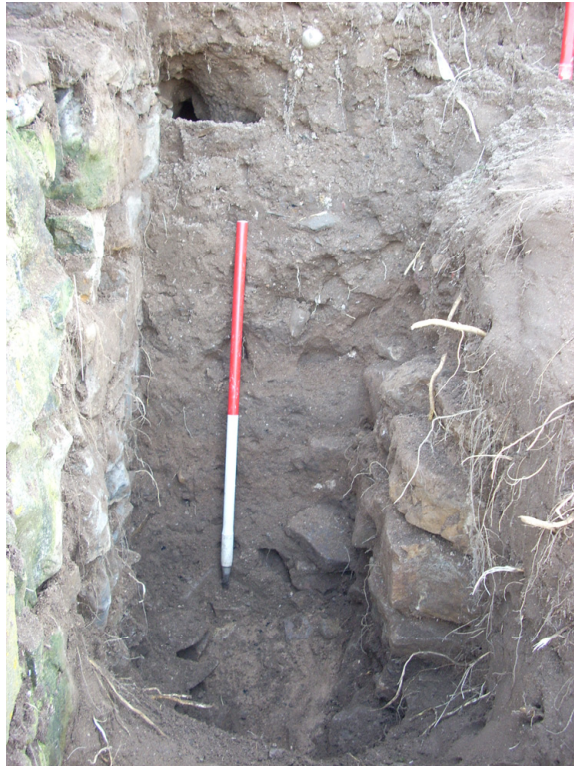
Figure 5: Slot 2 – post excavation shot showing walls 005 and 006. The photo also shows an animal burrow.

A probable animal burrow leading into the cliff face (Figure 5) was revealed against the face of **(005)**. The cavity formed by the animal burrow showed the wall **(005)** continuing into the section and cliff face.

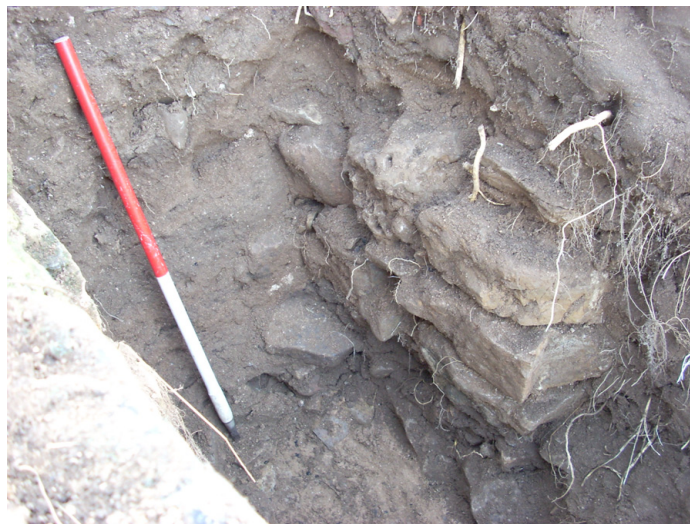
Figure 6: Slot 2 – showing wall 006

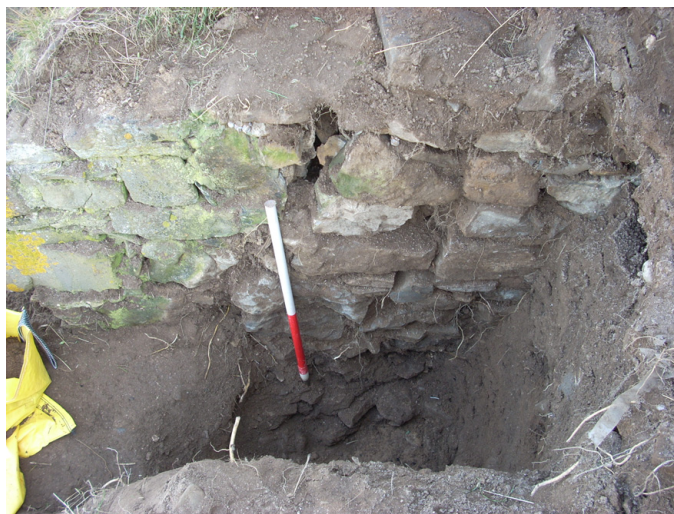
Figure 7: Slot 2 showing the outer lichen covered mortared (010) stone wall (005), with the inner drystone wall (005) to the right of the ranging rod

The northernmost part of the easternmost wall **(005)** was mortared **(010)**, but the buried portion of the wall was of dry stone construction. A dark yellow sand deposit **(009)** behind the easternmost wall **(005)** was probably placed during the construction of the wall to fill voids between the rear of the wall and the natural bedrock.

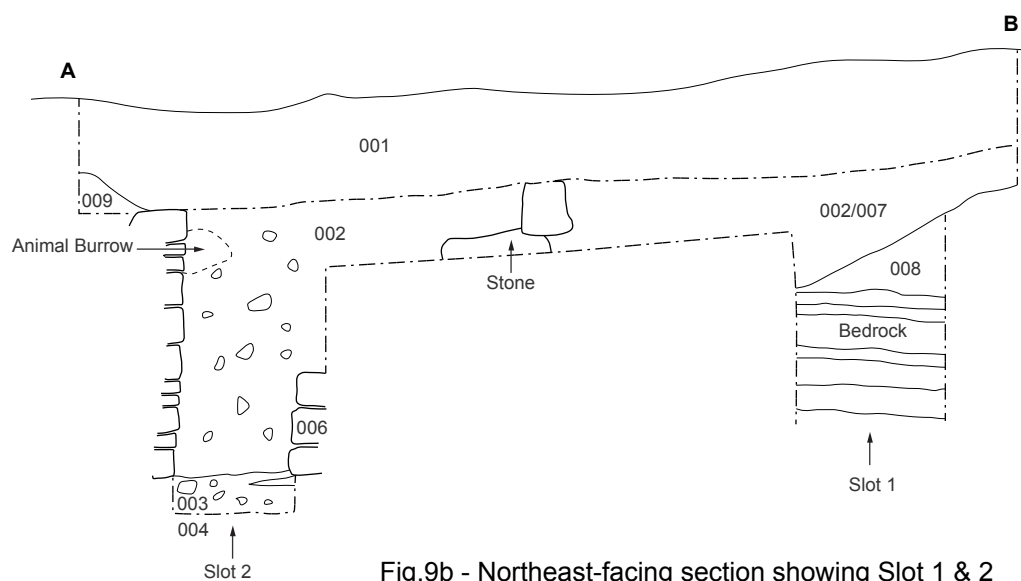
Fig.9b - Northeast-facing section showing Slot 1 & 2

Three World War Two tank defence blocks are positioned on the top of the cliff (Figure 9a). Turf and topsoil (**001**) was removed from an area of c.10m². Two slots (Slots 1 and 2) were excavated to explore key features that were exposed during the removal of the topsoil and turf (Figures 9a-b). The topsoil (**001**), which had a depth of between 0.5m and 0.6m overlay mid brown sandy loam (**002**) (Figure 9a-b).
